# Evaluation of Shear Bond Strength of Ceramic Repair With Resin Composite

**Aim:** To evaluate the shear bond strength of intra oral porcelain repair system using different surface treatments when fracture of porcelain with complete metal exposure. **Materials and Methods:** forty specimens were prepared in form of metal disks (8mm in diameter, this diameter is for each specimen and 15mm height) and randomly divided into 4 equal groups. The first two groups were treated with air abrasion. The other groups leaved untouched. Groups I and III were treated with 37% phosphoric acid while in groups II and IV the surface were treated with 9% hydrofluoric acid, after that the surfaces of all samples were treated with silane coupling agent then bonding and composite were applied according to the manufacturer instructions. All the samples were stored in a normal physiological saline for 7 days. Then the samples were thermocycled after that Shear bond strength was tested using universal testing machine. **Results:** The result showed that there was a highly significant difference between groups treated with  $Al_2O_3$  with those untreated one, the acid etch material. There was a highly sig

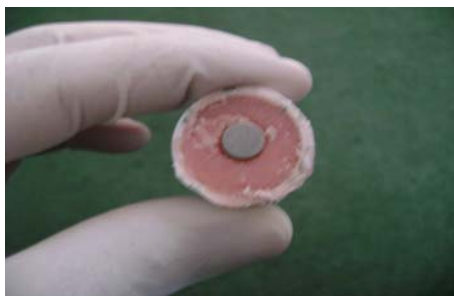
Self cure acrylic resin was mixed then loaded into the mold so that the sample will be completely imbedded in the acrylic resin totally except its examined surface that faced the glass slab (Figure 1).

Figure (1): Show metal cylinder imbedded in acrylic with plastic mold.

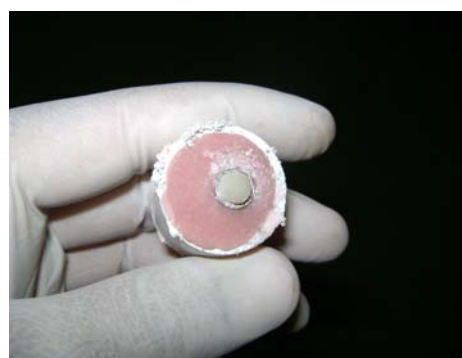
Using plastic transparent tube of 6mm diameter and 2mm high (so that the composite will be 2mm in thickness), the composite (tetric ceram from Vivadent, Liechtenstein) were applied on the surface cover it with celluloid strip and light cured for 40 seconds<sup>(11)</sup> (Figure 2).

Figure (2): Composite application on metallic cylinder.

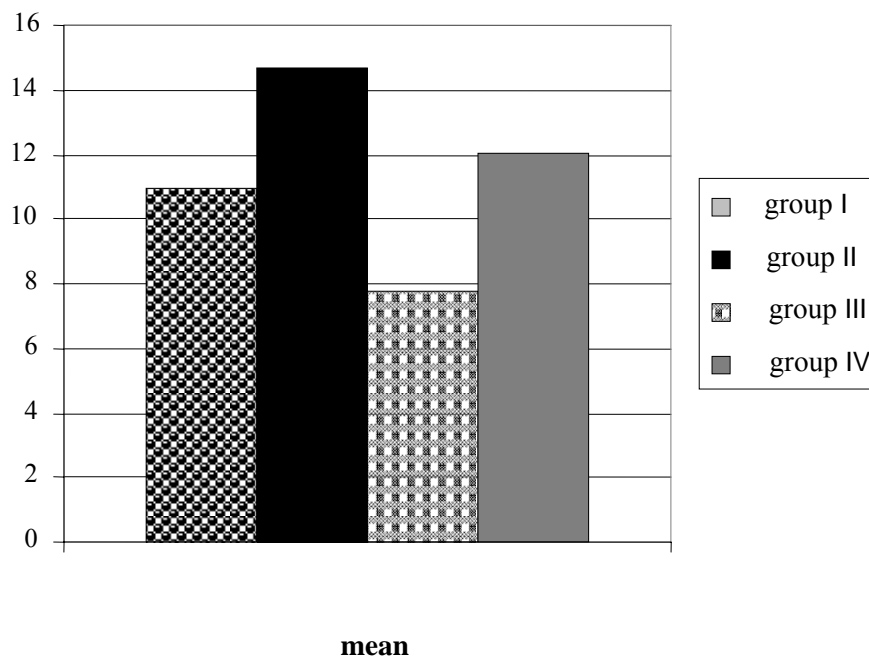
Bar chart showed that the mean value of shear bond strength in Mpa for all groups (Figure 3).

Figure (3): Bar chart show the mean value of shear bond strength in Mpa for all groups. I: Group one that treated with air abrasion using 50 µm Al<sub>2</sub>O<sub>3</sub> and 37% phosphoric acid; II: Group two that treated with air abrasion using 50 µm Al<sub>2</sub>O<sub>3</sub> and 9% hydrofluoric acid; III: Group three treated with 37% phosphoric acid only; IV: Group four treated with 9% hydrofluoric acid only

Further investigation using student t-test showed that there were highly significant differences between groups treated

with Al<sub>2</sub>O<sub>3</sub> and untreated groups.

Also student t-test showed highly significant differences between groups acid etched with hydrofluoric acid with corresponding groups acid etched using phosphoric acid (Table 2).
